Manhole Inspection Summary

Manhole # **S11SS1008MH**

Insp Date: **4/26/07 9:00 AM**

Location Address: **5025 PIMLICO AVE**

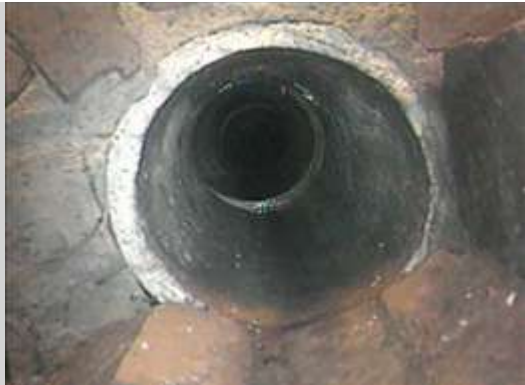
4 O'Clock Inflow

6 in. Circular Gravity Sewer

Pipe In @ 4 O'Clock

Deposits: ☒ None ☐ Mud ☐ Sludge ☐ Debris ☐ Grease

Infiltration: **None**

Pipe Seal Cond: **Sound**

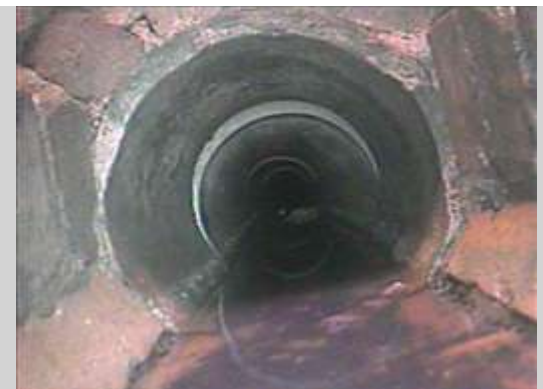
6 O'Clock Inflow

8 in. Circular Gravity Sewer

Pipe In @ 6 O'Clock

Deposits: ☒ None ☐ Mud ☐ Sludge ☐ Debris ☐ Grease

Infiltration: **None**

Pipe Seal Cond: **Sound**

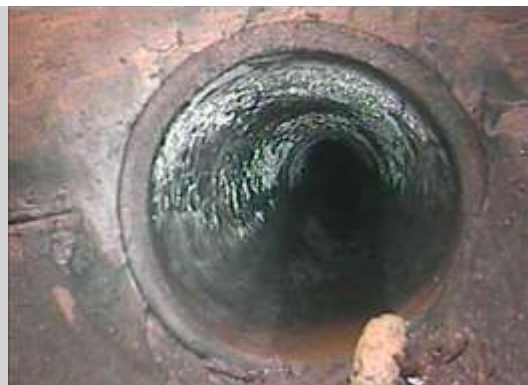
9 O'Clock Inflow

8 in. Circular Gravity Sewer
Pipe In @ 9 O'Clock

Infiltration: **None** Pipe Seal Cond: **Sound**
